Manhole Inspection Summary

Manhole # S55M__014MH

Insp Date: **10/27/08 2:37 PM**

Location Address: **3700 odonnell st**

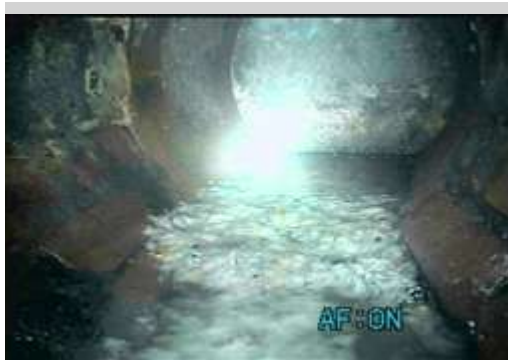
Misc.

channel debris

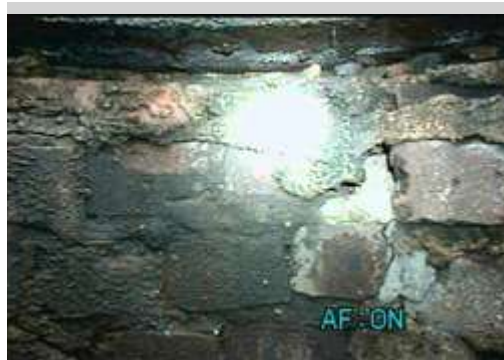
Defect 2

☒ **Cracked**

crack corbel

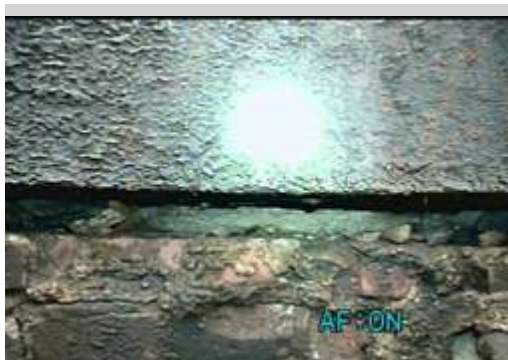
Defect 1

☒ **Leaks**

☒ **Cracked**

☒ **Deteriorated**

☒ **Joint**

cracked and deteriorated chimney/frame adj, frame infiltration, chimney infiltration

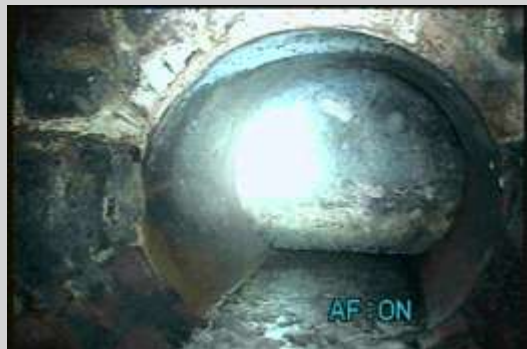
7 O'Clock Inflow

blocked off

Connects To: Stub connection / abandoned
